MICHIGAN DEPARTMENT OF TRANSPORTATION

STR 6940

BRIDGE SAFETY INSPECTION REPORT

Facility CURTIS ROAD	Latitude / Longitude 43.7992 / -84.3886	MDOT Structure ID 56200042000B010	Structure Condition Good Condition(7)
Feature TITTABAWASSEE RIVER	Length / Width 316.6 / 41.67	Owner County: Midland(56)	
Location .05 MI W OF WATER RD	Built / Recon. / Paint / Ovlly. 1997 / / /	TSC Mt. Pleasant(4A)	Operational Status A Open, no restriction(A)
Region / County Bay(4) / Midland(56)	Material / Design 5 Prestressed Concrete / 05 Multiple Box Beam	Last NBI Inspection 09/10/2015 / 3OVP	Scour Evaluation 5 Stable w/in footing

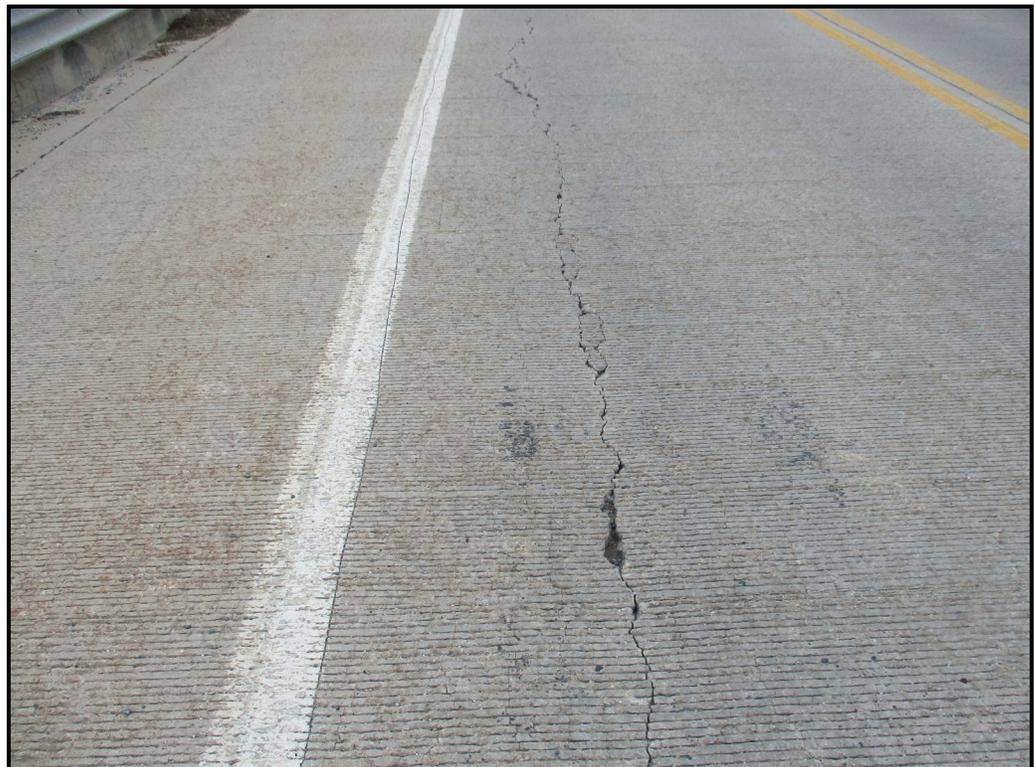
09/11	09/13	09/15	
16. Approach Pavement	5	5	5	Approach slabs have hairline-1/16" map cracking spaced every 2"-4" throughout. Both approaches have a 1/4" wide longitudinal crack in WBD lane. (09/15) Approach slabs have hairline-1/16" map cracking spaced every 2"-4" throughout. Both approaches have a 1/4" wide longitudinal crack in WBD lane. (09/13) Approach slabs have hairline-1/16" map cracking spaced every 2"-4" throughout. (09/11)
17. Approach Shoulders Sidewalks	7	7	6	Concrete approach shoulders have hairline-1/16" map cracks. Approach curb and gutter has shrinkage cracks. (09/15) Concrete approach shoulders have hairline-1/16" map cracks. Approach curb and gutter in place (09/13) Concrete approach shoulders have hairline-1/16" map cracks. Approach curb and gutter in place (09/11)

*Longitudinal
crack in west
approach slab*

Recommendation Type	Priority	Description
Detailed Insp.	L	Investigate cause of cracking in fascias
Appr. Pavement	L	Replace approach slab in future
Slope Repair	H	Repair undermining at SE approach curb
Joint Repair	M	Clean out joints yearly
Overlay	M	New healer/sealer in 2-4 years.

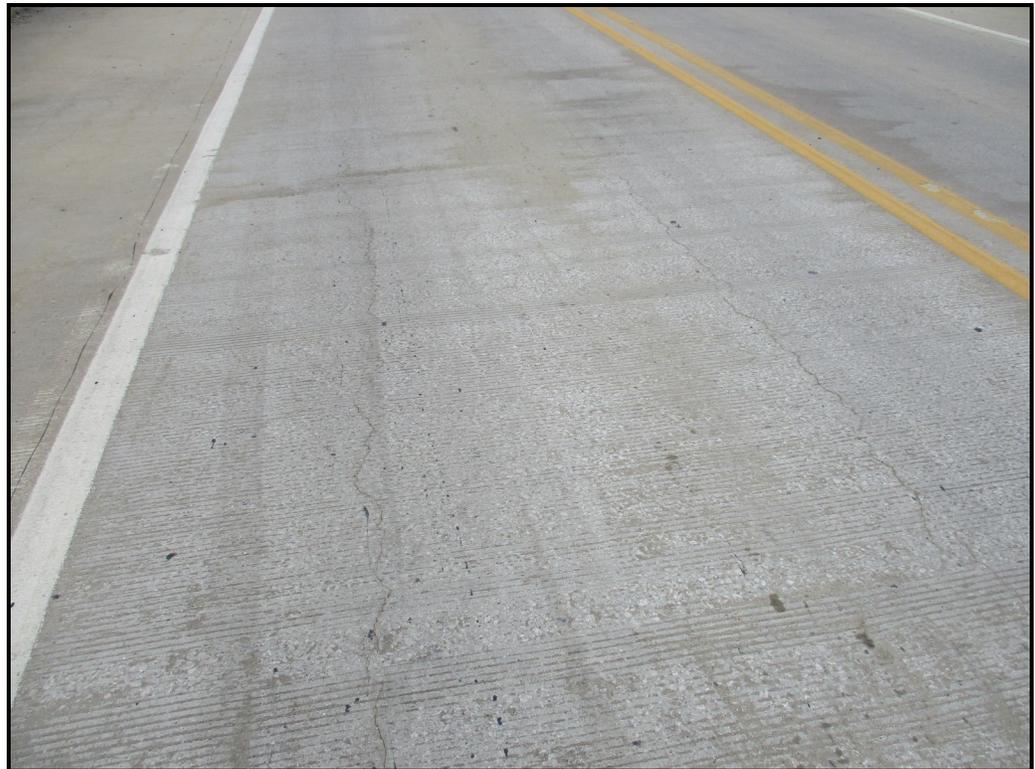
09/11	09/13	09/15	
1. Surface (SIA-58A)	7	7	6	Healer/sealer on deck, 80% worn off in lanes, intact in both shoulders. Visible longitudinal cracks along beam lines. Map cracks in span 2W, west end. (09/15) Healer/sealer on deck, starting to wear off in wheel lines. (09/13) New healer/sealer on concrete deck, no visible cracks. (09/11)

*Cracks in
concrete deck*

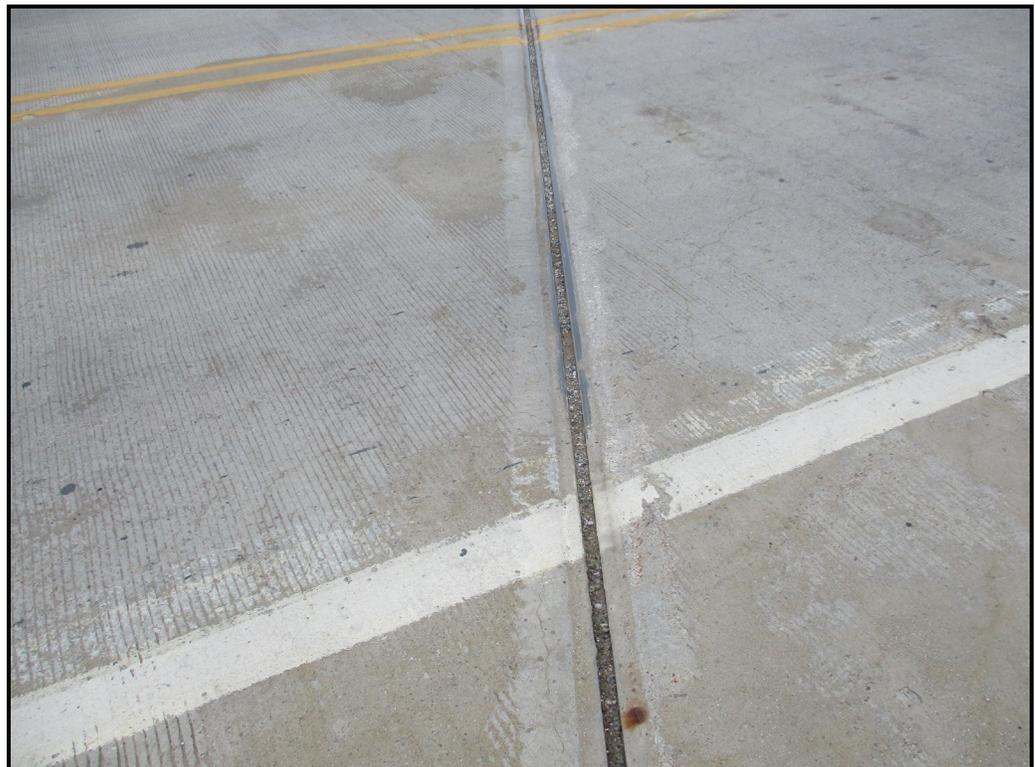
2. Expansion Joints	7	6	6	EJ3 joints over both piers are full of dirt. Some neoprene missing at E3 joints. At west and east E3 joint, HMA patch in joint header, approximately 5 sft with 3 sft of spall. (09/15) EJ3 joints over both piers are full of dirt. Some neoprene missing at E3 joints. At east E3 joint, HMA patch in joint header, approximately 3 sft. (09/13) Over both piers, joints are full of dirt. (09/11)

*West expansion
joint*

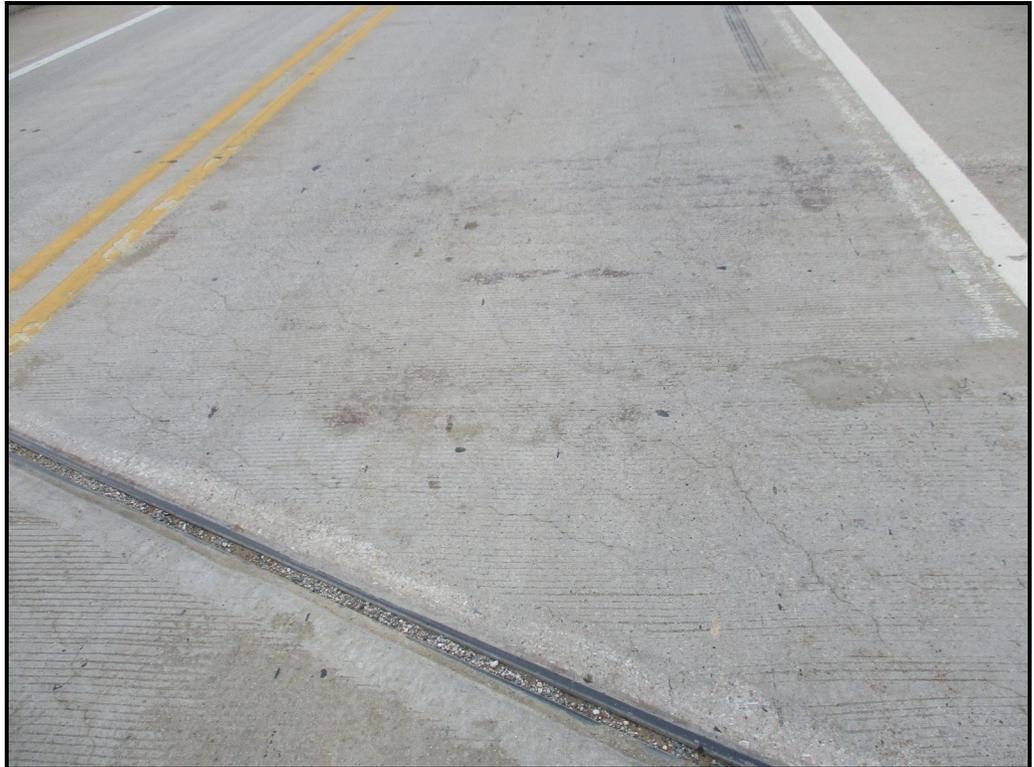
*Map cracks in
concrete
surface*

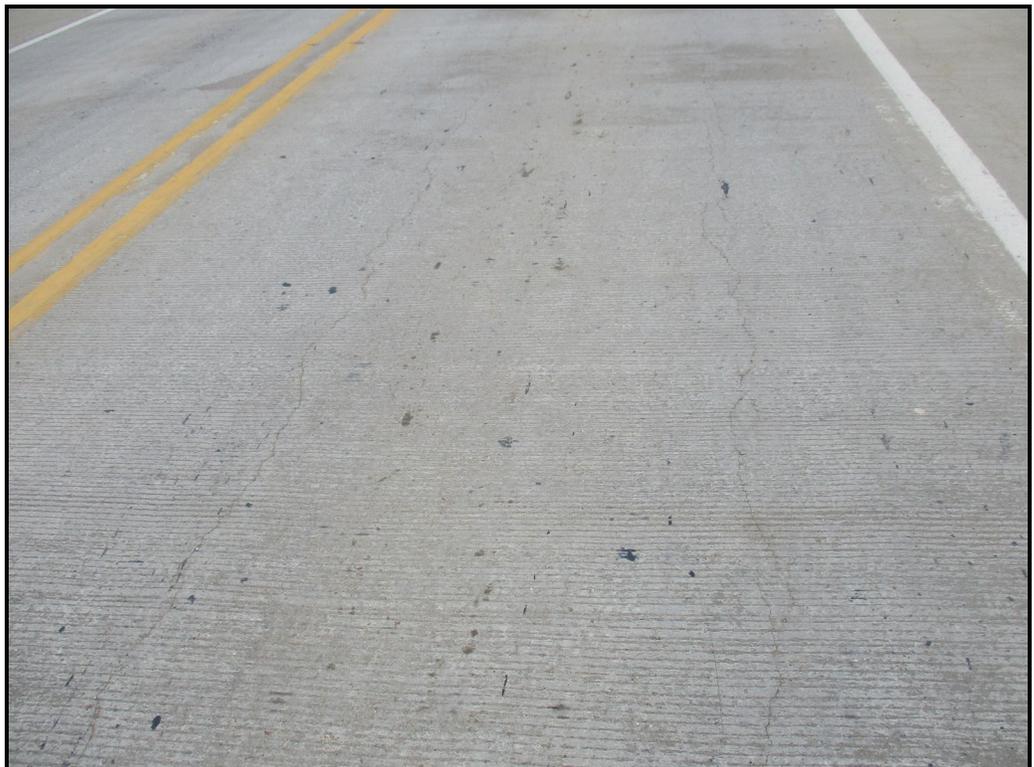
*Longitudinal
cracks in
concrete
surface*

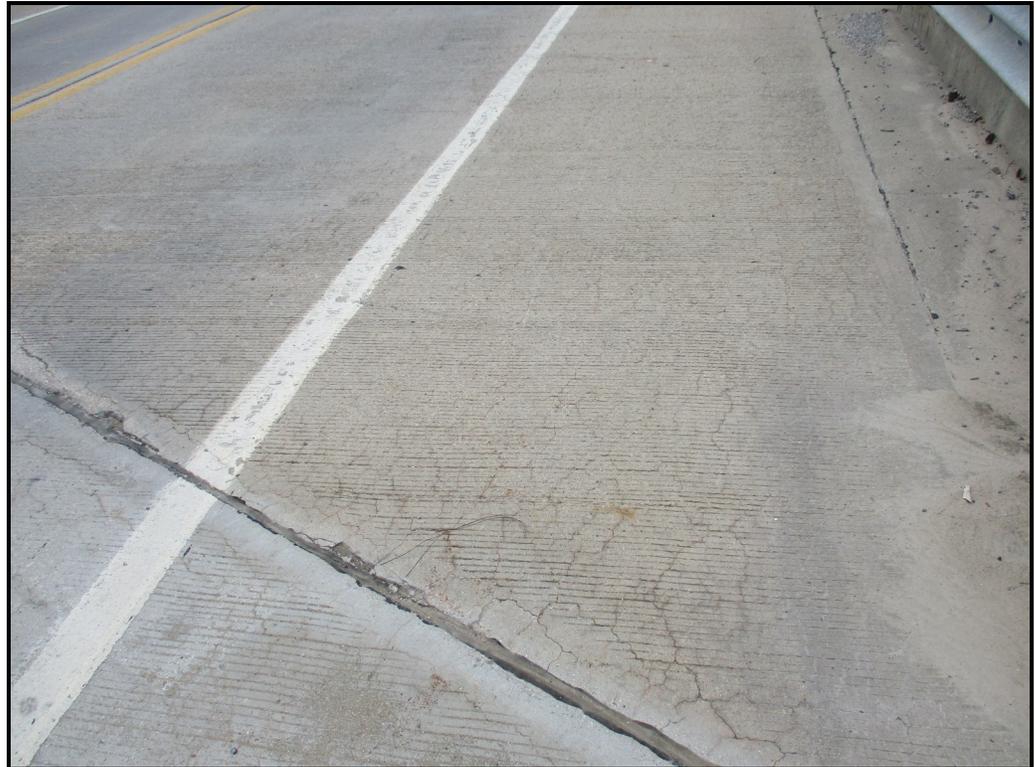
*Heavy map
cracks in east
approach slab*

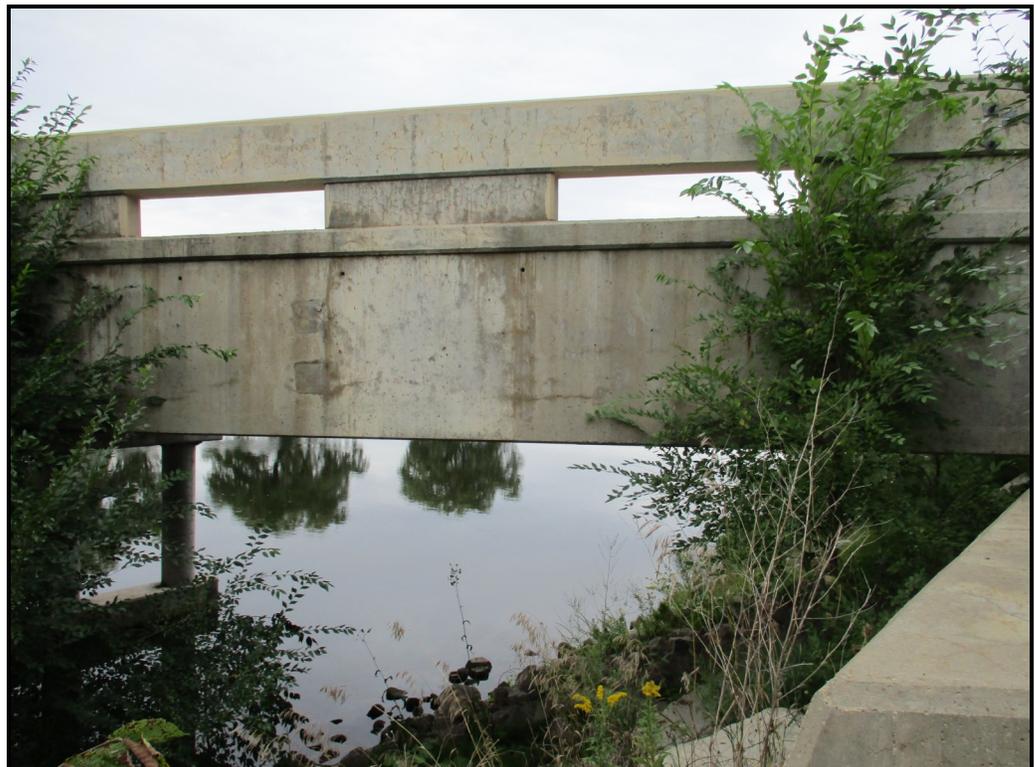
9. Stringer (SIA-59)	7	7	7	SW fascia beam has hairline shear crack, NW has 3 hairline shear cracks (difficult to see with vegetation). NE fascia has 2 hairline shear cracks. North and South fascias over both piers, both beam ends have hairline shear cracks. North & South fascias have hairline horizontal cracks, approx 5"-12" from bottom of beam, all spans. Hairline cracks propagating from post tension pockets. Span 1W, beam 4S has hairline longitudinal crack on bottom, approximately 4'-6' long. (09/15) SW fascia beam has hairline shear crack, NW has 3 hairline shear cracks (difficult to see with vegetation). NE fascia has 2 hairline shear cracks. North and South fascias over both piers, both beam ends have hairline shear cracks. North & South fascias have hairline horizontal cracks, approx 5"-12" from bottom of beam, all spans. (09/13) SW fascia beam has hairline shear crack, NW has 3 hairline shear cracks. NE fascia has 2 hairline shear cracks. North and South fascias over both piers, both beam ends have hairline shear cracks. North & South fascias have hairline horizontal cracks, approx 12" from btm of beam, all spans (only visible in south fascia). (09/11)

*Hairline cracks
in south fascia
beam*

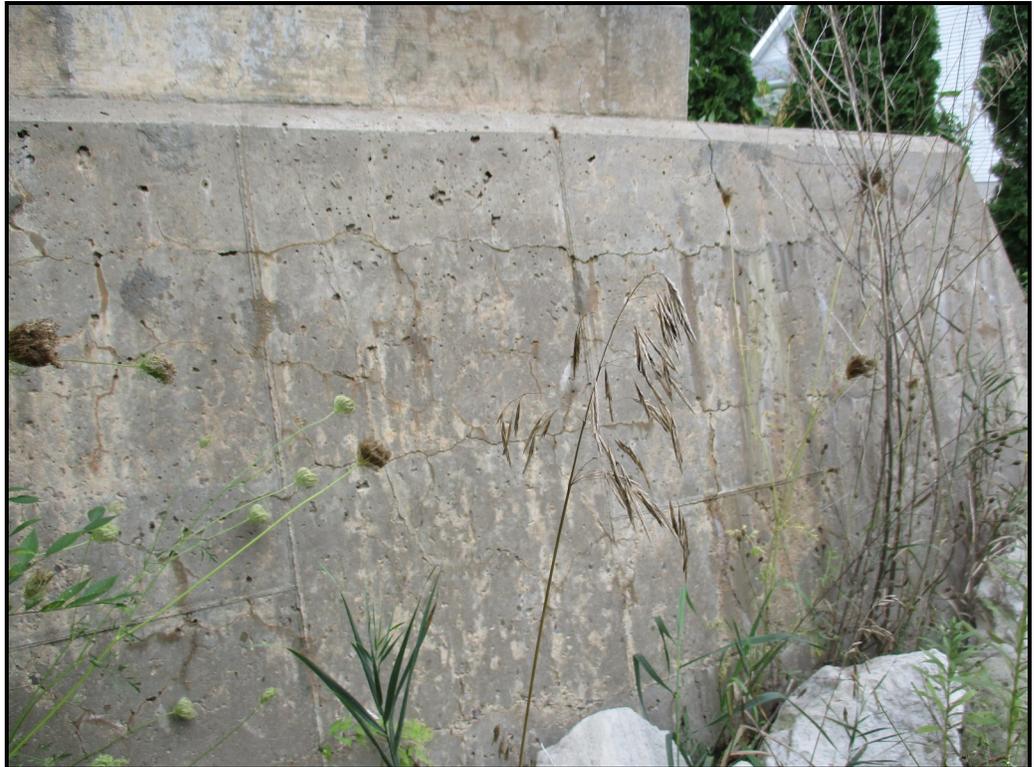
09/11	09/13	09/15	
13. Abutments (SIA-60)	7	7	7	Both abutments have ASR/shrinkage cracking outside of bearing area. All 4 slope walls have ASR/shrinkage cracks throughout, some open to 1/8" wide (09/15) Both abutments have ASR/shrinkage cracking outside of bearing area. All 4 slope walls have ASR/shrinkage cracks, some open to 1/8" wide (09/13) Both abutments have ASR/shrinkage cracking outside of bearing area. All 4 slope walls have ASR/shrinkage cracks also (09/11)

*Cracks in west
abutment
outside bearing
area*

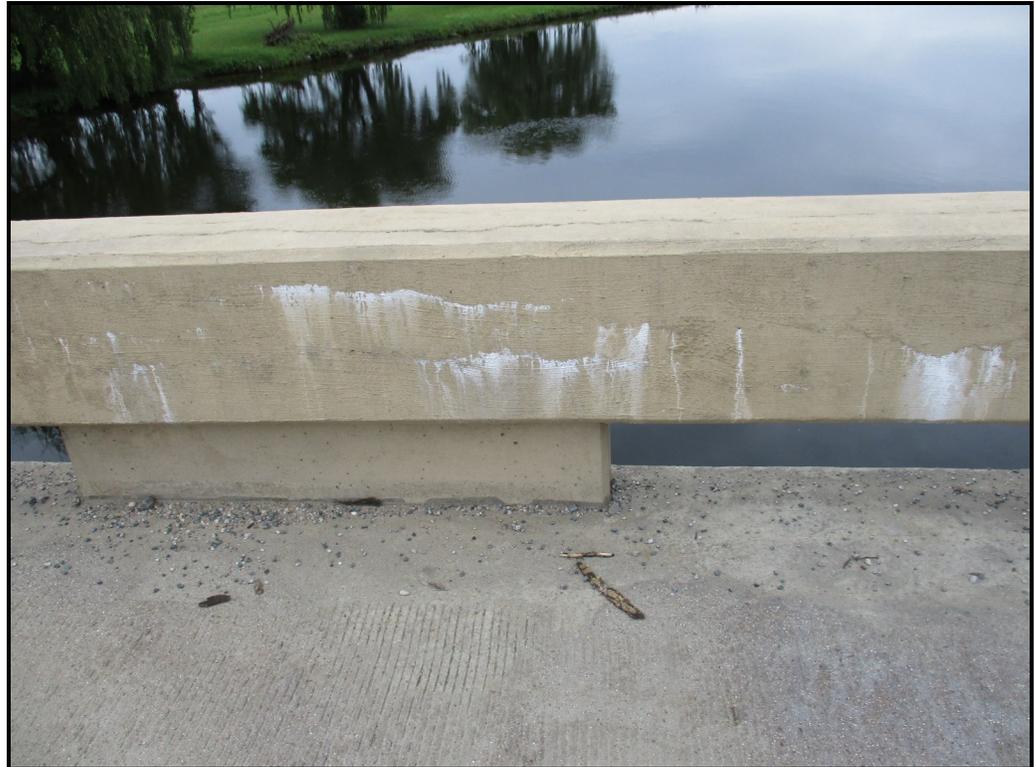
3. Other Joints	6	N	N	(09/15) (09/13) Some neoprene missing at E3 joints. At east E3 joint, spall in joint header, approximately 3 sft. (09/11)
4. Railings	7	7	7	New surface sealer on inside, hairline shrinkage/ASR cracks on outside. No open cracks in railing. North rail has horizontal leaching cracks in span 2W (09/15) New surface sealer on inside, hairline shrinkage/ASR cracks on outside. No open cracks in railing (09/13) New surface sealer on inside, hairline shrinkage/ASR cracks on outside. No open cracks in railing (09/11)

*Leaching
cracks in north
railing*

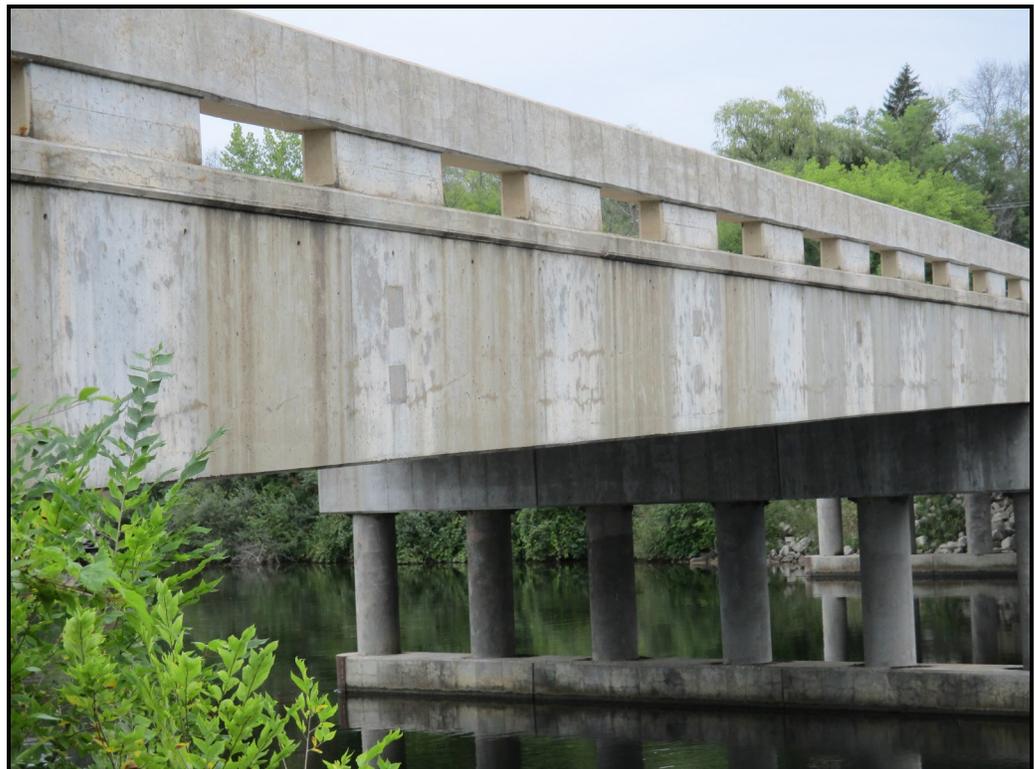
*Hairline cracks
in north fascia*

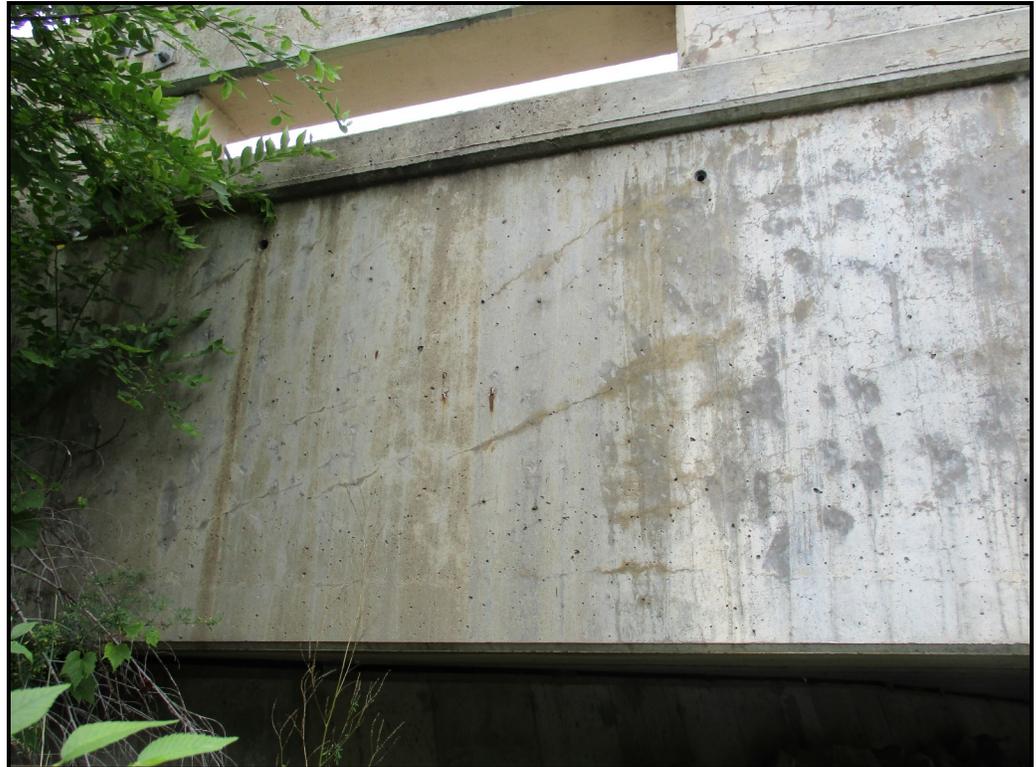
*Shear cracks in
SW fascia
beam*

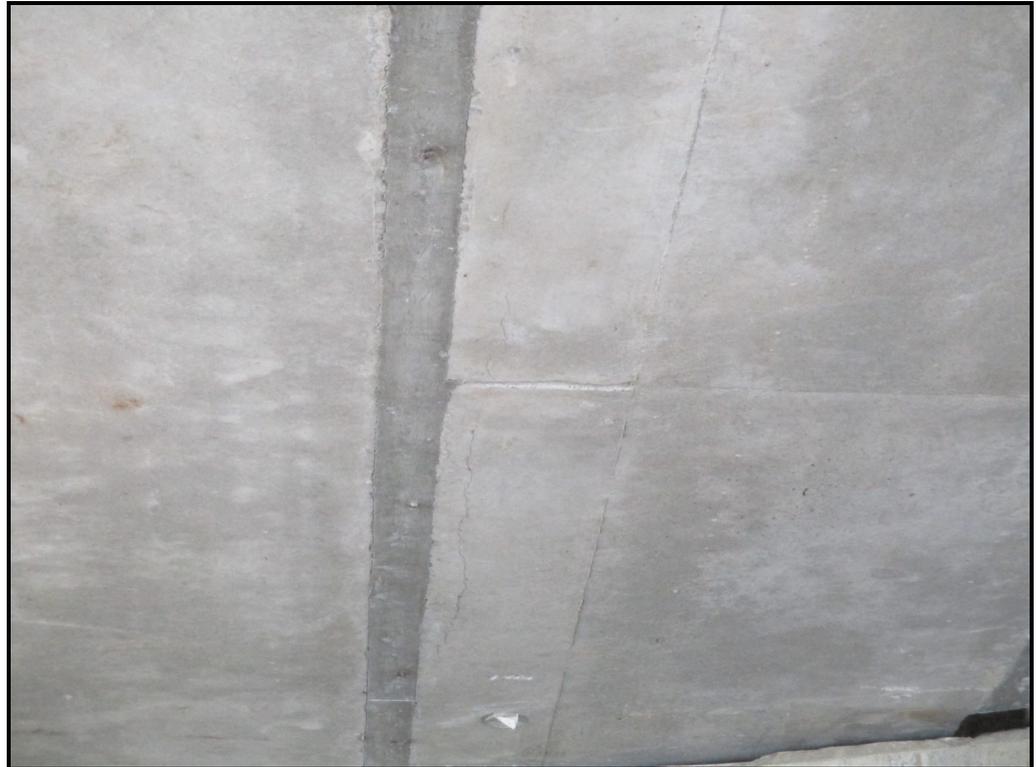
*Hairline crack
in bottom of
beam 4S, span
1W*

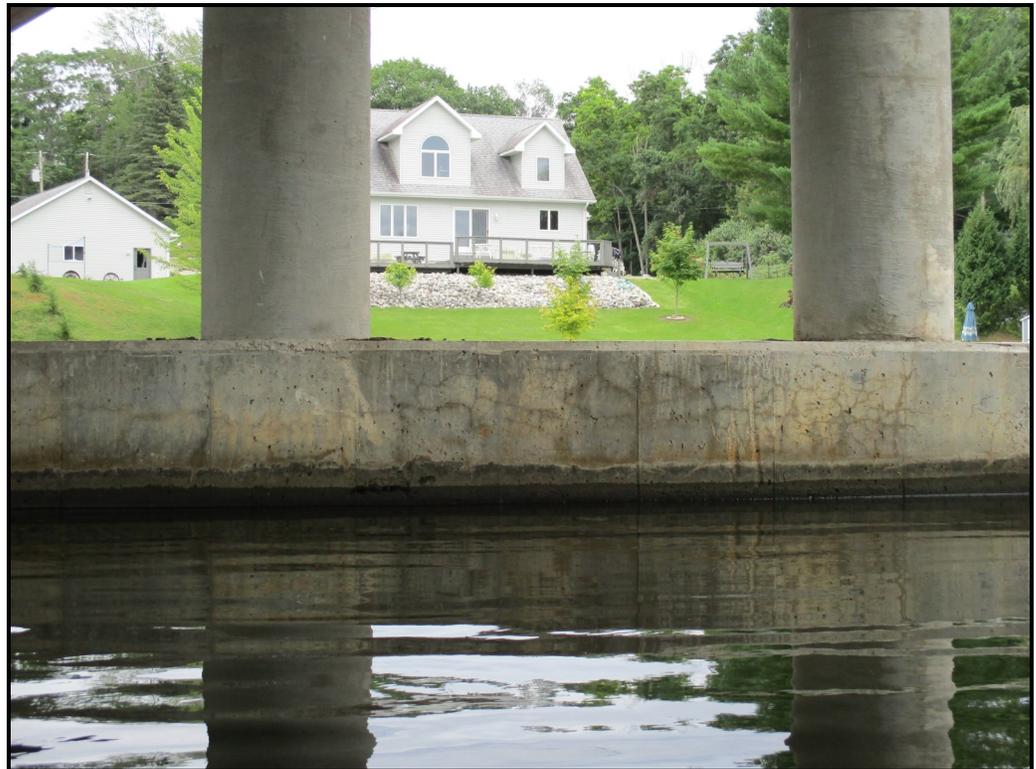
14. Piers (SIA-60)	7	7	7	Pier walls have hairline-1/16" cracks. East pier cap, east face has 3 patched areas (09/15) Pier walls have hairline-1/16" cracks. East pier cap, east face has 3 patched areas (09/13) Pier walls have hairline-1/16" cracks. No footing exposed on either pier. East pier cap, east face has 3 patched areas (09/11)

*Hairline map
cracks in pier
wall*

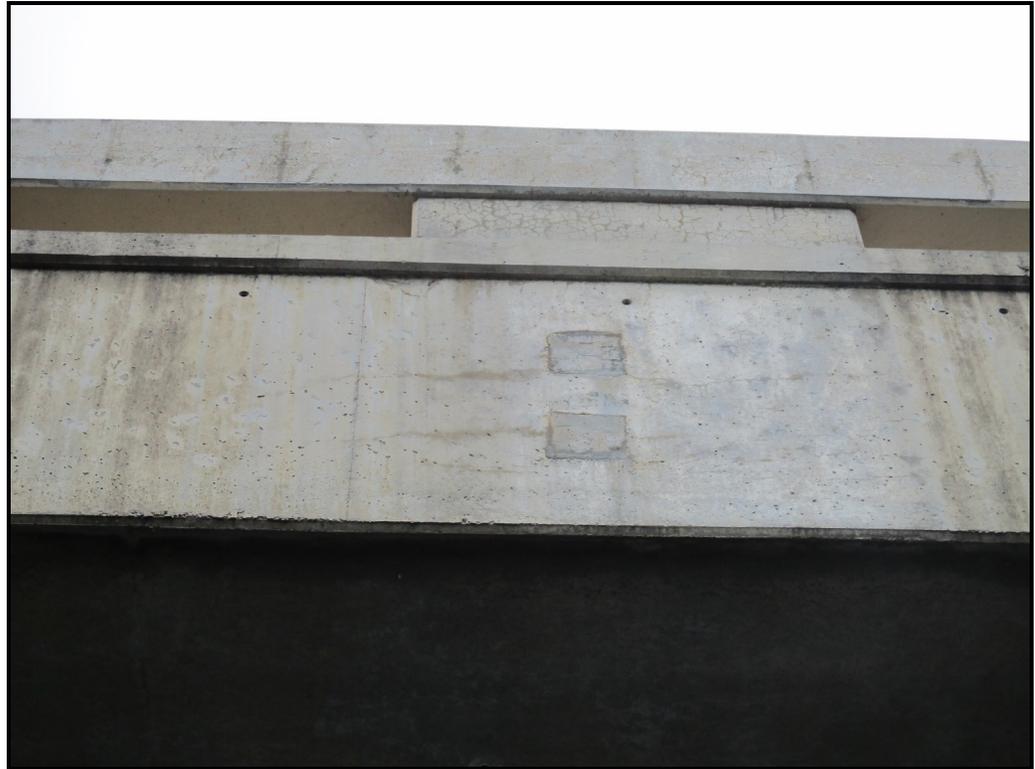
*Hairline cracks
propagating
from post
tension pocket*

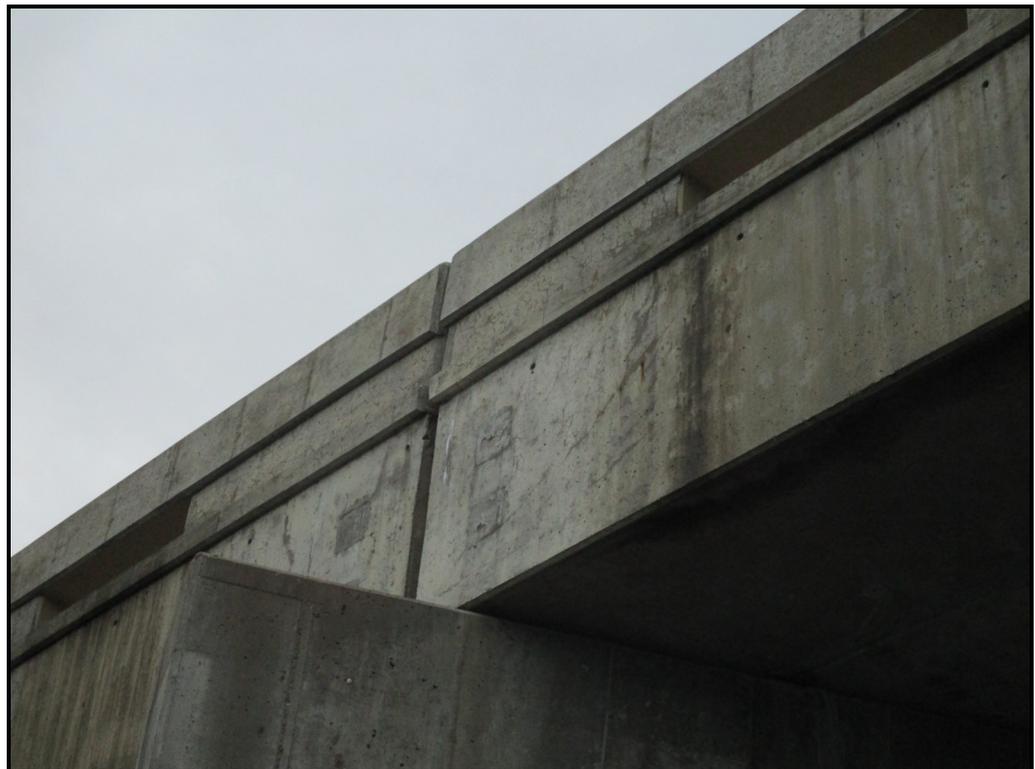
*Hairline cracks
in beam ends
over pier*
