MICHIGAN DEPARTMENT OF TRANSPORTATION

STR 6992

BRIDGE SAFETY INSPECTION REPORT

Midland County 2015 Bridge Inspections
Magruder Rd over Pine River
SN 6992
GLEG Project No. 1015-2-336
September 14, 2015

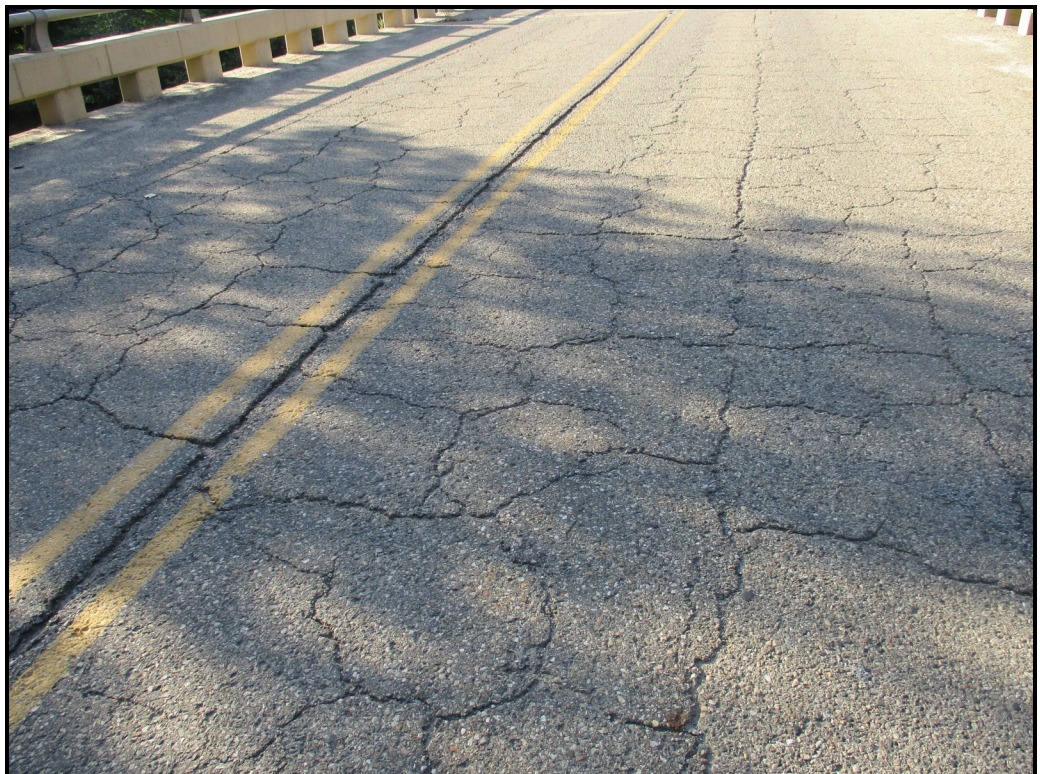
09/11	09/13	09/15	
1. Surface (SIA-58A)	4	4	4	Map cracking throughout HMA, spaced 1-2'. HMA patch along open centerline joint. (09/15) Map cracking throughout HMA, spaced 1-2'. (09/13) Map cracking throughout HMA, spaced 1-2'. Outer 3' covered with gravel. (09/11)

*Cracking
throughout
HMA surface*

Recommendation Type	Priority	Description
Detailed Insp.	M	Investigate cause of cracking in piers.
Slope Repair	M	Fill abutment erosion.
Joint Repair	H	Blow out joints yearly. Replace all joints
Overlay	M	Mill HMA and place membrane with new HMA.
Super Repair	H	Patch box beams
Substr Repair	H	Clean off tops of piers.

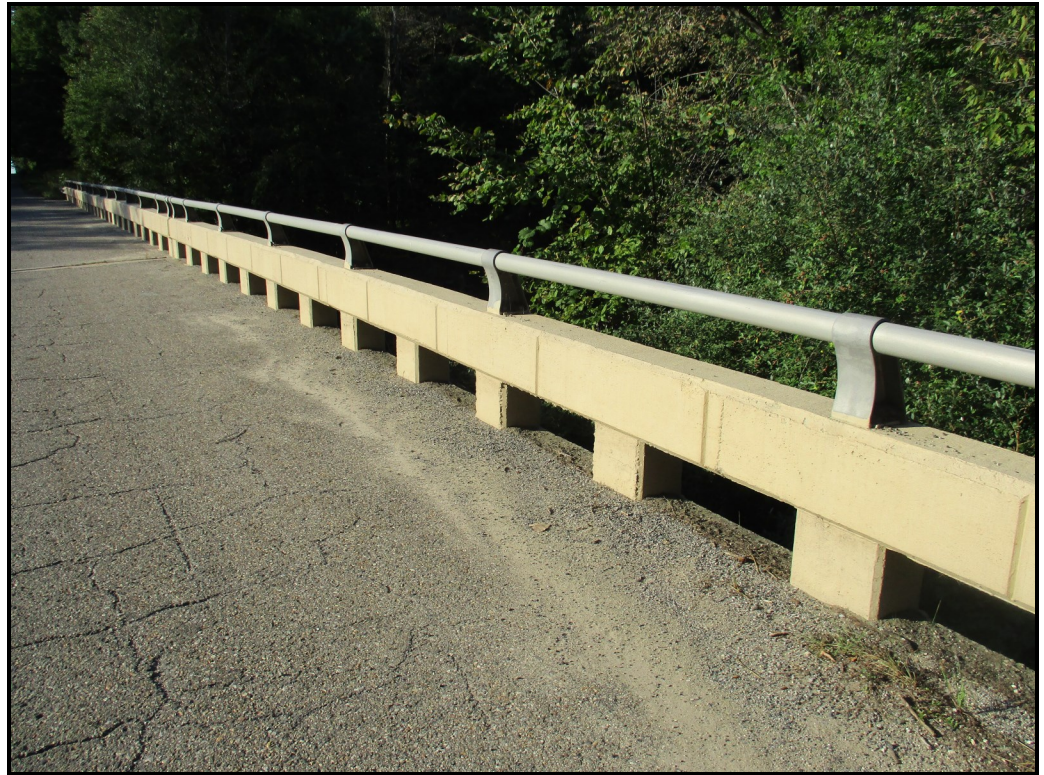
4. Railings	7	7	7	Concrete open parapet with 1' stems and round ped tube. Loose tube mid span of span 2s in east rail. Concrete surface sealer on railing. (09/15) Concrete open parapet with 1' stems and round ped tube. Loose tube mid span of span 2s in east rail. Concrete surface sealer on railing. (09/13) Concrete surface sealer on railing (09/11)

Bridge railing

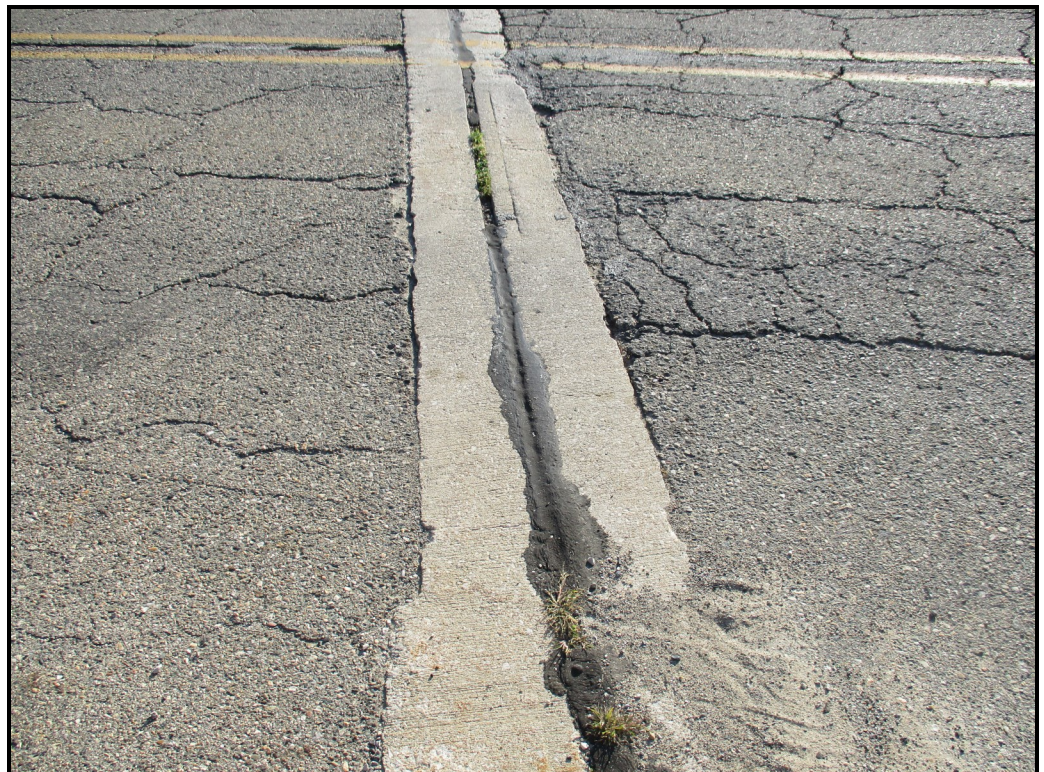
2. Expansion Joints	6	5	5	Joint at south pier is full of dirt, 1sft spall in header in NBD lane, and steel header is loose in SBD lane. Compression joint at north pier, missing 75% of hot poured rubber, vegetation growing out of joint, pier cap wet from leakage. (09/15) Joint at south pier is full of dirt, 1sft spall in header in NBD lane, and steel header is loose in SBD lane. Compression joint at N pier, missing 50% of hot poured rubber, vegetation growing out of joint, pier cap wet from leakage. (09/13) Joint at south pier is full of dirt. 1sft spall in header in NBD lane. (09/11)

Expansion joint

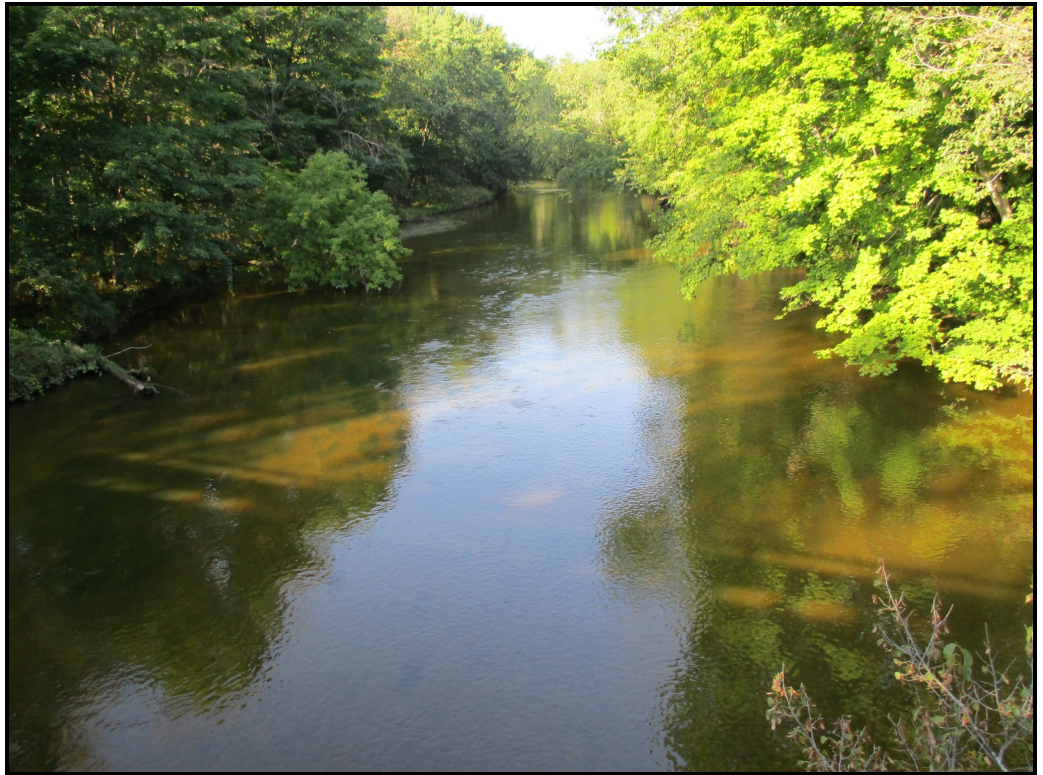
19. Utilities				None noted on bridge. (09/15) None noted on bridge. (09/13) None noted on bridge (09/11)
20. Channel (SIA-61)	7	7	7	Wide channel with heavy trees and vegetation on banks. Fallen tree against Pier 2s wall on upstream end. (09/15) Wide channel with heavy trees and vegetation on banks. Fallen tree against Pier 2s wall on upstream end. (09/13) Wide channel with heavy trees and vegetation on banks. (09/11)

*Upstream
channel section*

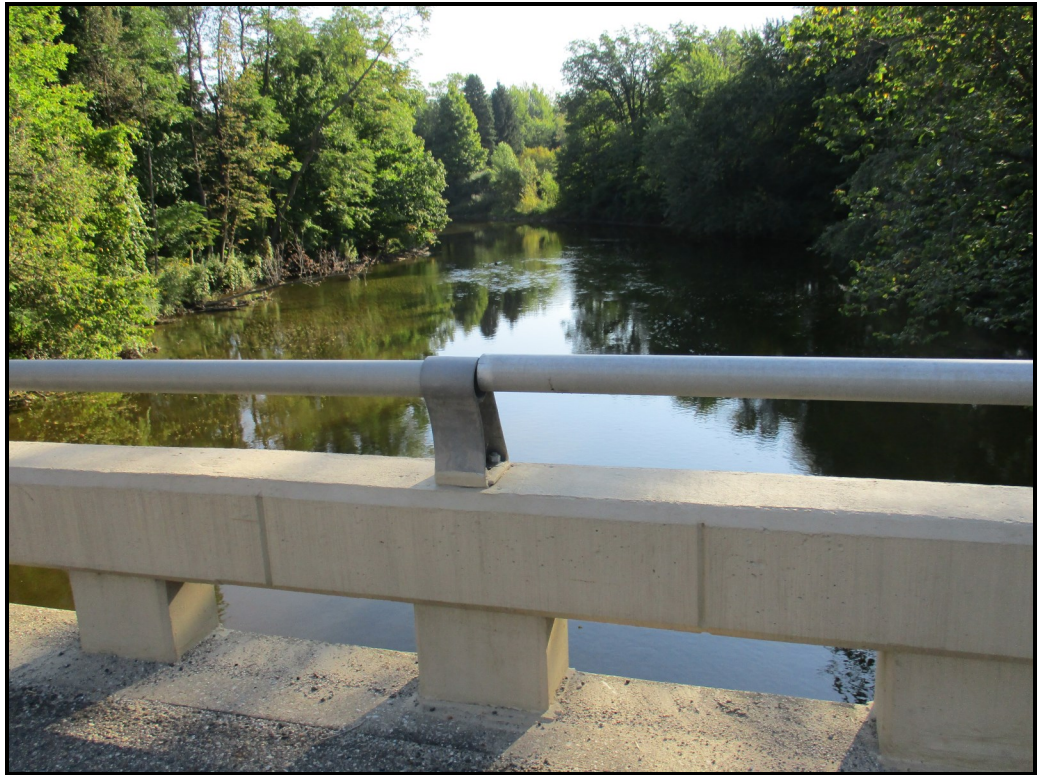
*Loose tube on
east rail*

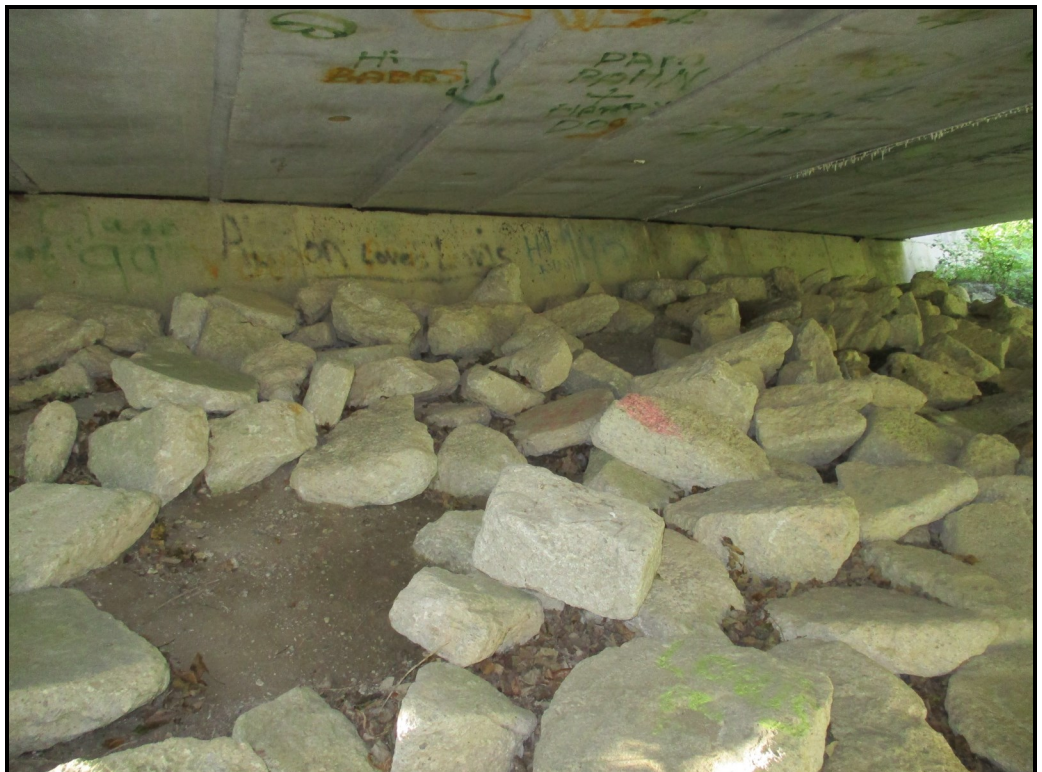
09/11	09/13	09/15	
13. Abutments (SIA-60)	7	7	7	North abutment has shrinkage/ASR cracks outside of bearing area. South abutment has ASR outside bearing area, both east and west sides. (09/15) North abutment has shrinkage/ASR cracks outside of bearing area. South abutment has ASR outside bearing area, both east and west sides. (09/13) North abutment has shrinkage/ASR cracks outside of bearing area. South abutment has ASR outside bearing area, both east and west sides. (09/11)

*South
abutment*

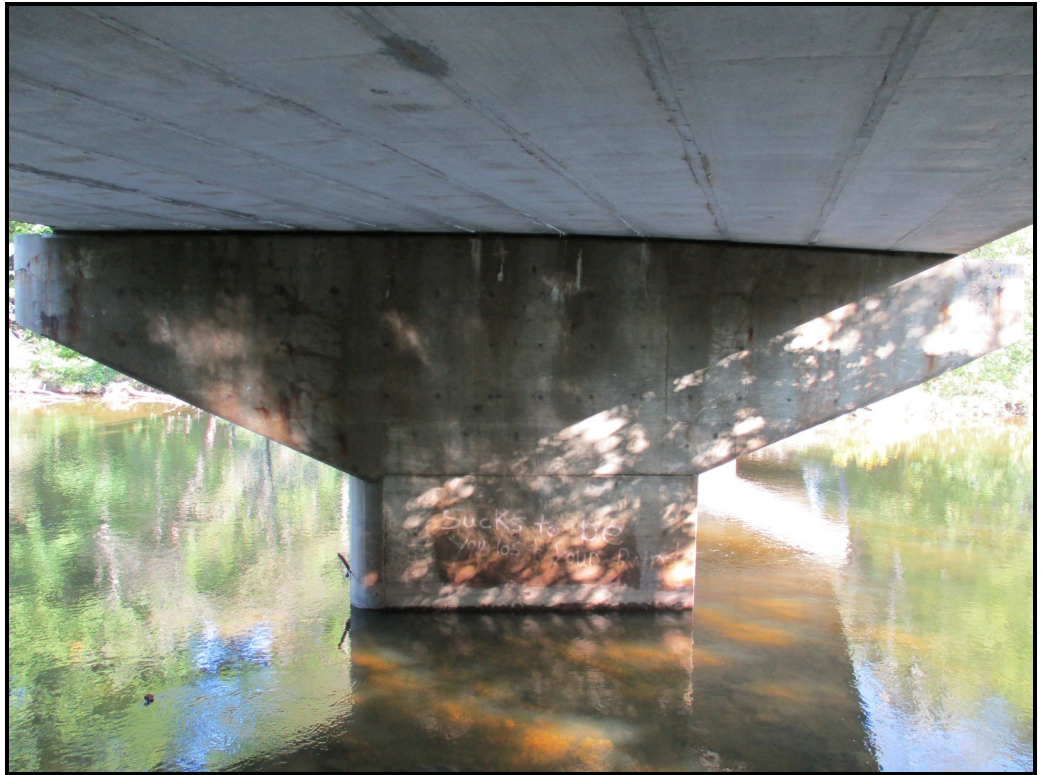
14. Piers (SIA-60)	5	5	5	Hammerhead piers. Both piers have shrinkage/ASR cracks throughout. Shallow steel in areas is creating rust. Cracks are hairline. Ends of pier caps have vegetation growing. Stem on N pier has a 1/16" vertical crack at each end with some spalling around cracks. Incipient spall (2 sft) on hammerhead south face of north pier. (09/15) Hammerhead piers. Both piers have shrinkage/ASR cracks throughout. Shallow steel in areas is creating rust. Cracks are hairline. Ends of pier caps have vegetation growing. Stem on N pier has a 1/16" vertical crack at each end with some spalling around cracks. Incipient spall (2 sft) on hammerhead south face of north pier. (09/13) Hammerhead piers. Both piers have shrinkage/ASR cracks throughout. Shallow steel in areas is creating rust. Cracks are hairline. Eastend of pier caps has vegetation growing. Stem on N pier has a 1/16" vert crack at each end. Debris stuck on south pier is removed. (09/11)

South pier

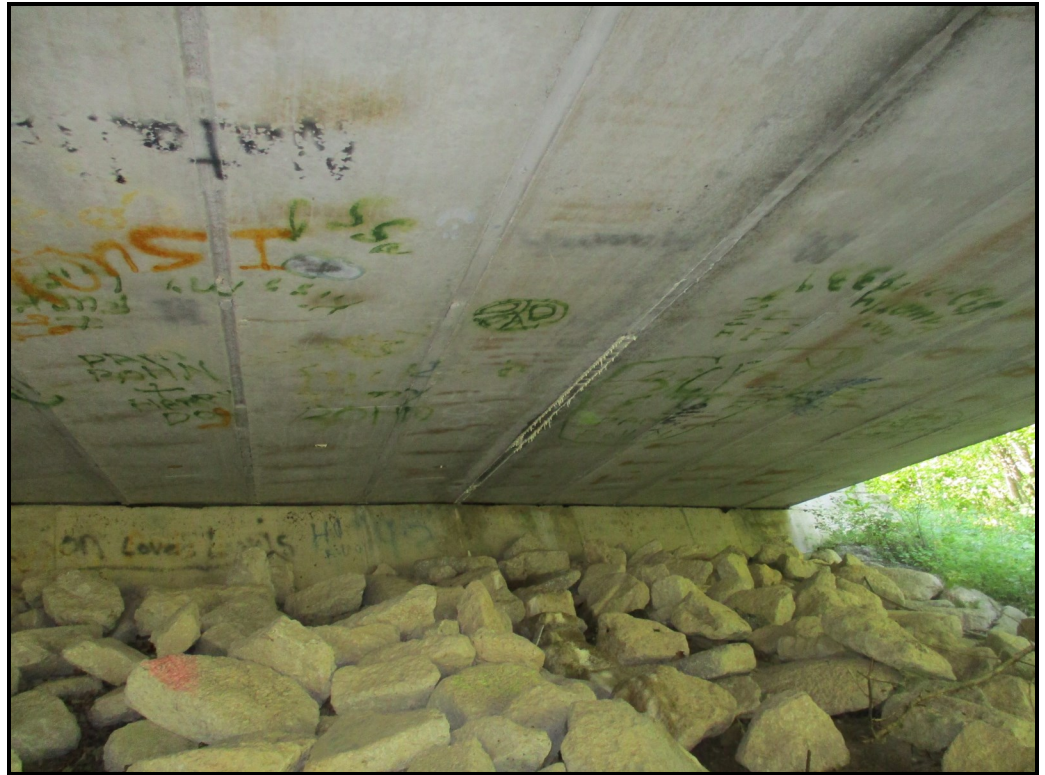
7. Deck (SIA-58)	6	6	6	HMA surface is map cracked throughout. Efflorescence at grout joints, heavist at piers. (09/15) HMA surface is map cracked throughout. Efflorescence at grout joints, heavist at piers. (09/13) Efflorescence at grout joints, heavist at piers. (09/11)

*Leakage along
grout joint*

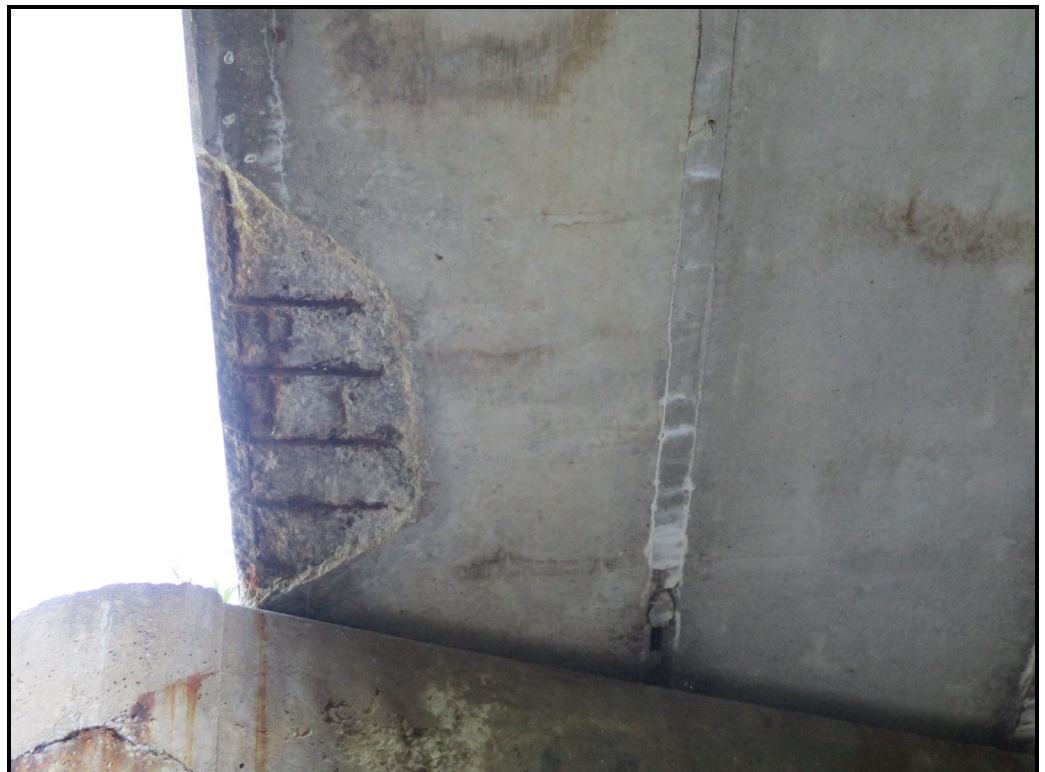
9. Stringer (SIA-59)	6	6	6	Hairline cracks in west fascia beam ends over north pier. Post tension pocket grout spalled in west fascia beam ends over south pier, east fascia over north pier. Span 3S, beam 6W has a 14"x7" spall on bottom with no exposed steel, east fascia has hairline leaching cracks on bottom near midspan. Span 2S, beam 6W at south pier has a 1sft delamination. Span 1S, beam 1W at pier, 1'x3' spall with exposed resteel and 2 exposed strands. County patched east fascia beam on span 3S. Vegetation growth between beam ends at piers. (09/15) Hairline cracks in west fascia beam ends over north pier. Post tension pocket grout spalled in west fascia beam ends over south pier, east fascia over north pier. North span, beam 6W has a 14"x7" spall on bottom with no exposed steel. South span, beam 1W at pier, hairline longitudinal leaching crack and 1'x0.5' spall with 1 strand exposed. County patched east fascia beam on north span. Vegetation growth between beam ends at piers. (09/13) Hairline cracks in west fascia beam ends over north pier. Post tension pocket grout spalled in west fascia beam ends over south pier, east fascia over north pier. North span, beam 6 has a 14"x7" spall on bottom with no exposed steel. South span, beam 1W at pier, hairline longitudinal leaching crack and 1'x0.5' spall with steel. North span, east fascia, 3'x0.5' spall with 2 exposed strands and a 1'x4' delamination at midspan. On 10/11/11, County patched east fascia beam on north span, no exposed strand. (09/11)

*Span 1S, beam
1W, spall on
bottom at pier*

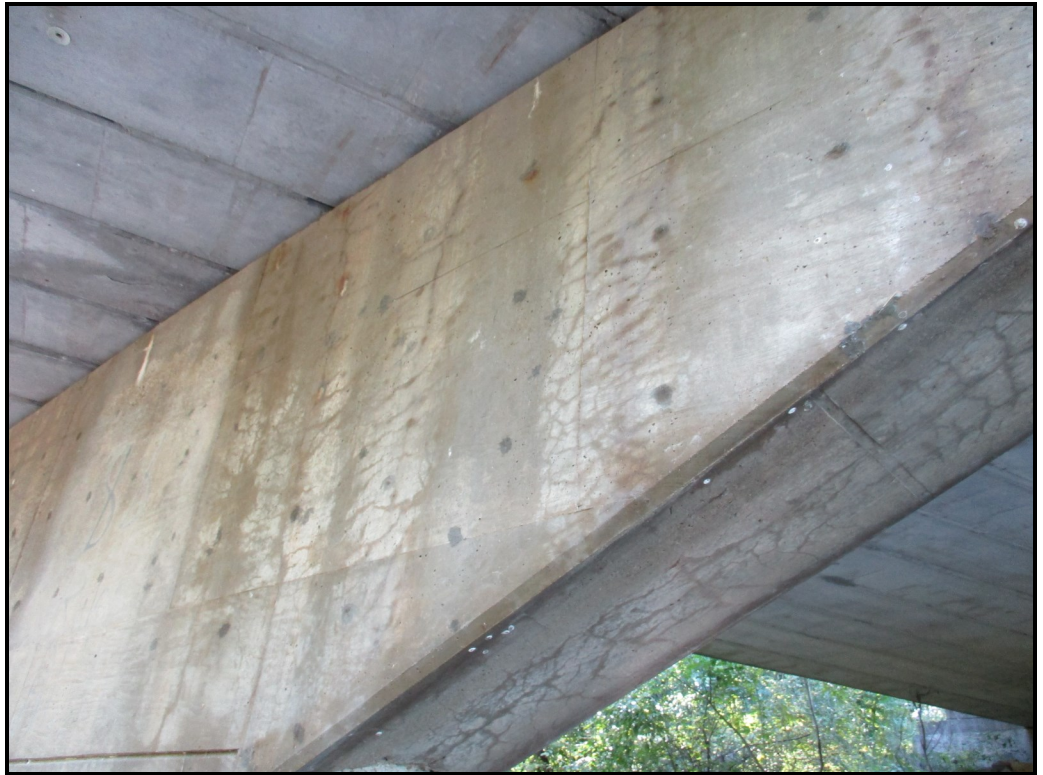
*Hairline
cracking
throughout
pier*

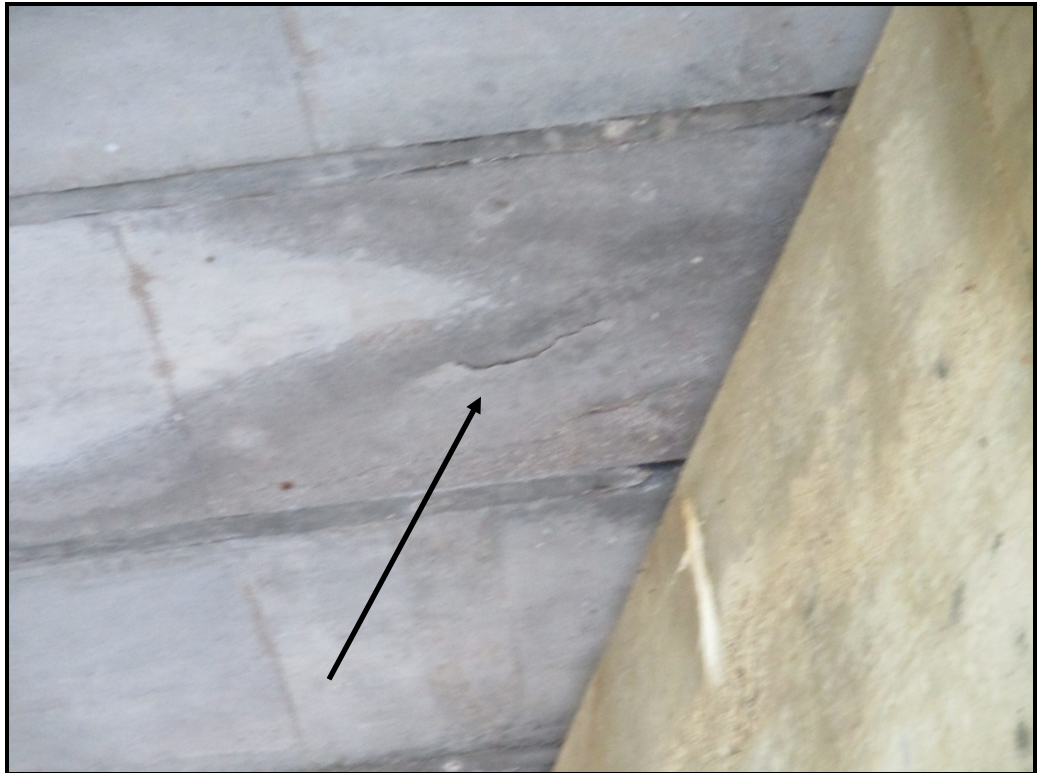
*Delamination
on bottom of
beam 6W, span
2S*

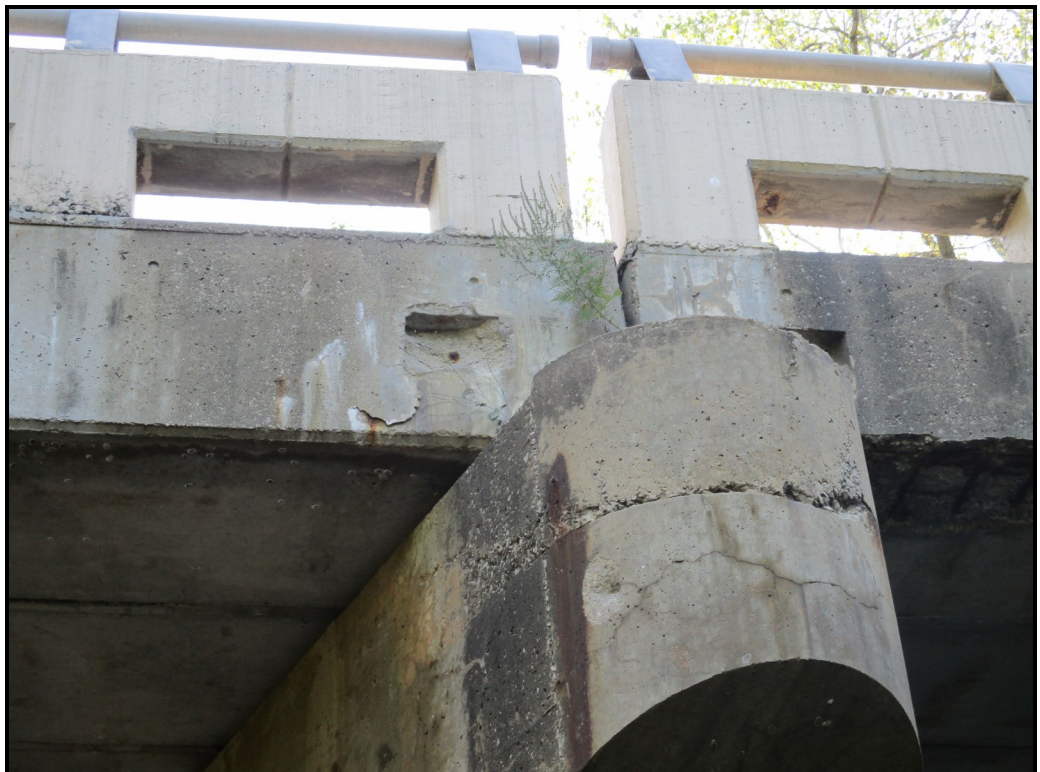
*Spalled grout
in post tension
pockets on west
fascia*

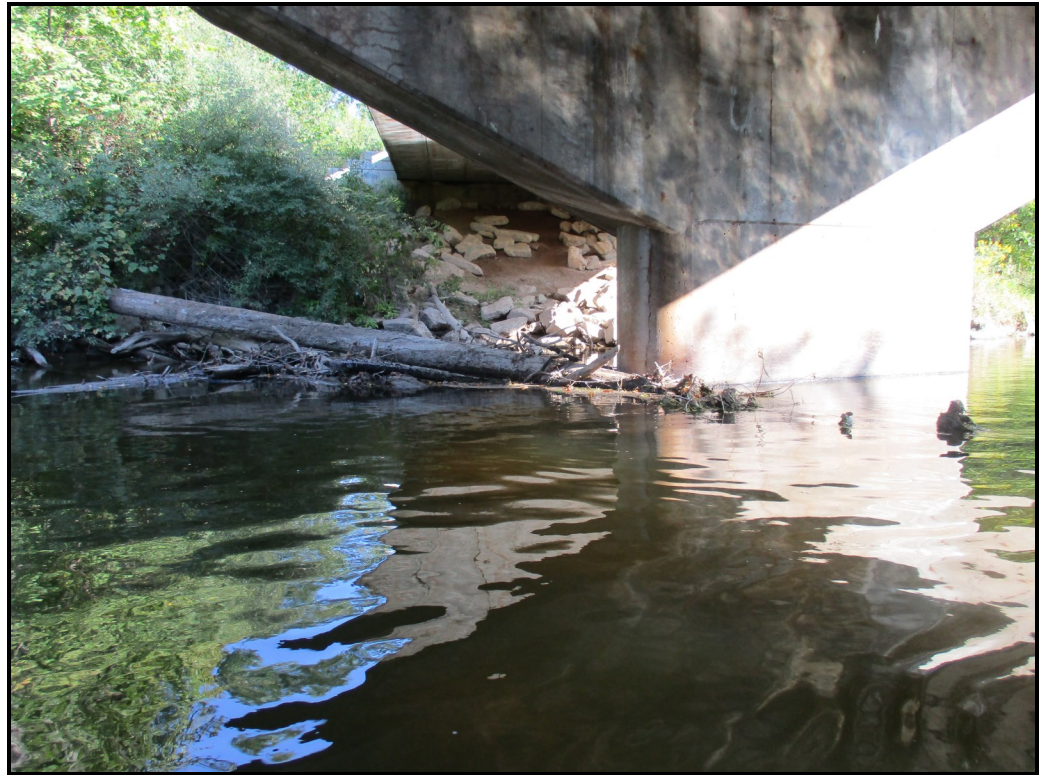
*Debris stuck on
north pier*

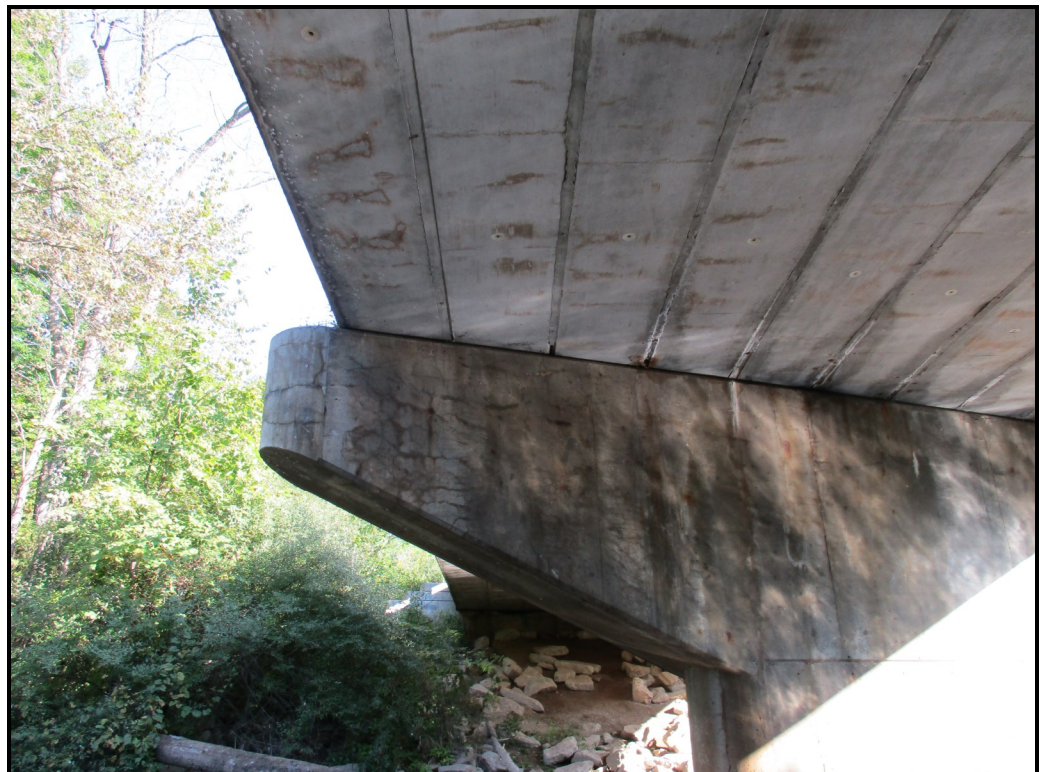
*Map cracks in
north pier*

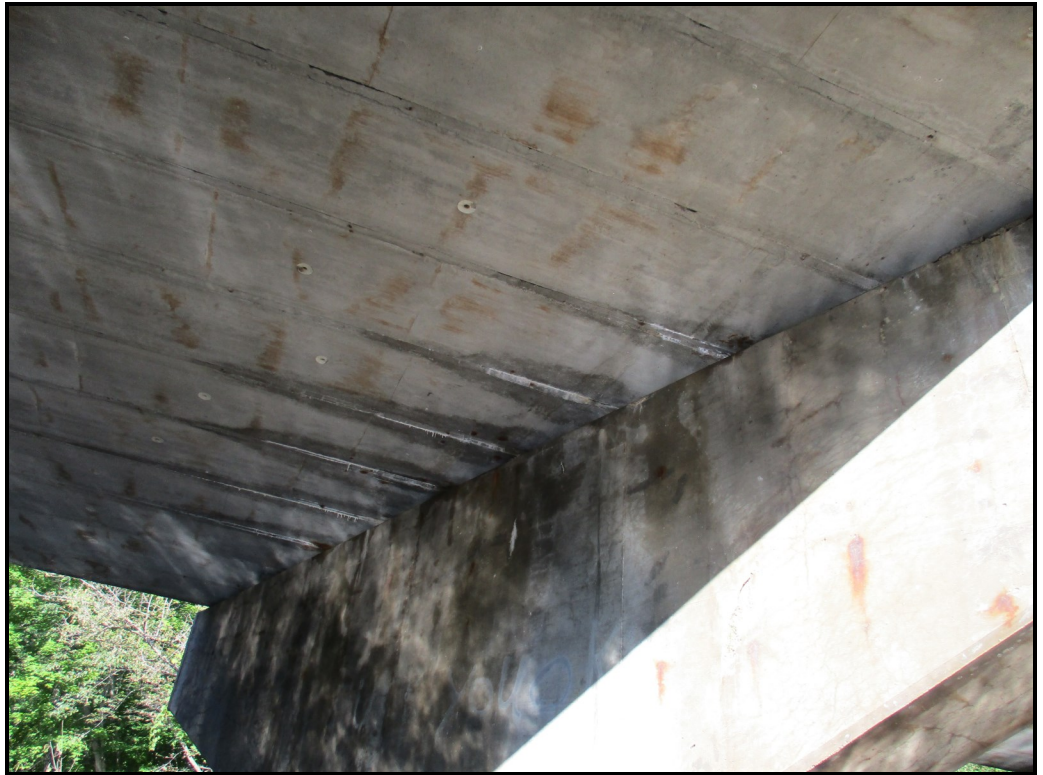
*Leakage in
grout joints at
pier*

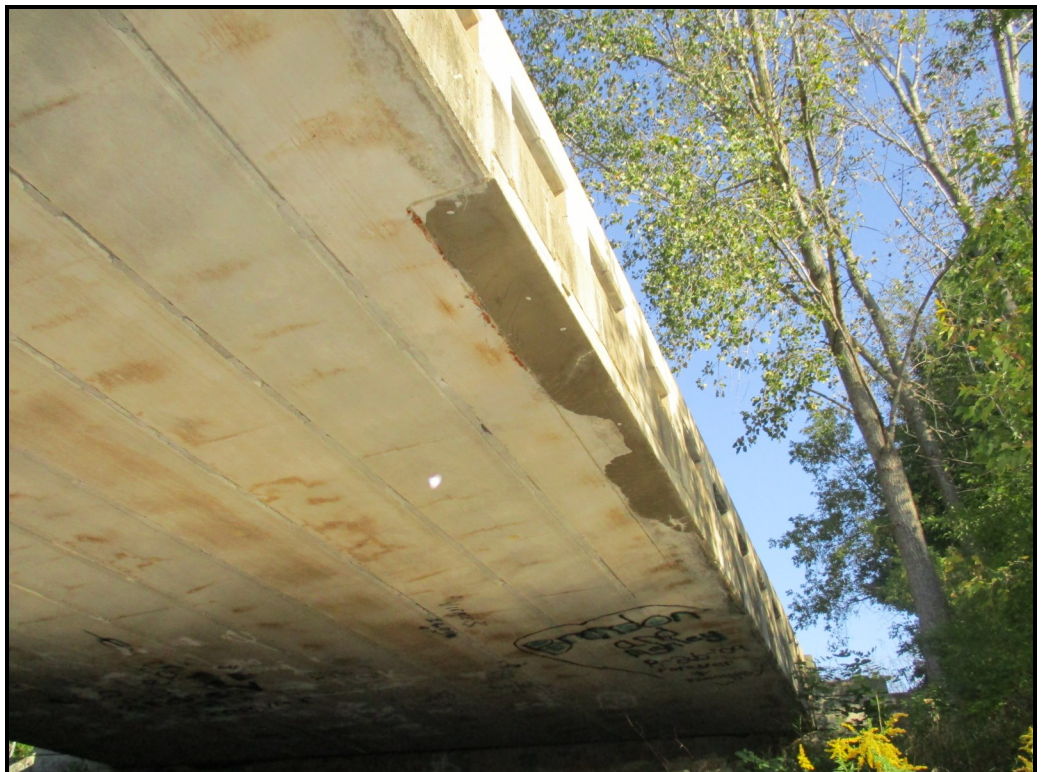
*Patched area
on east fascia
beam, span 3S*

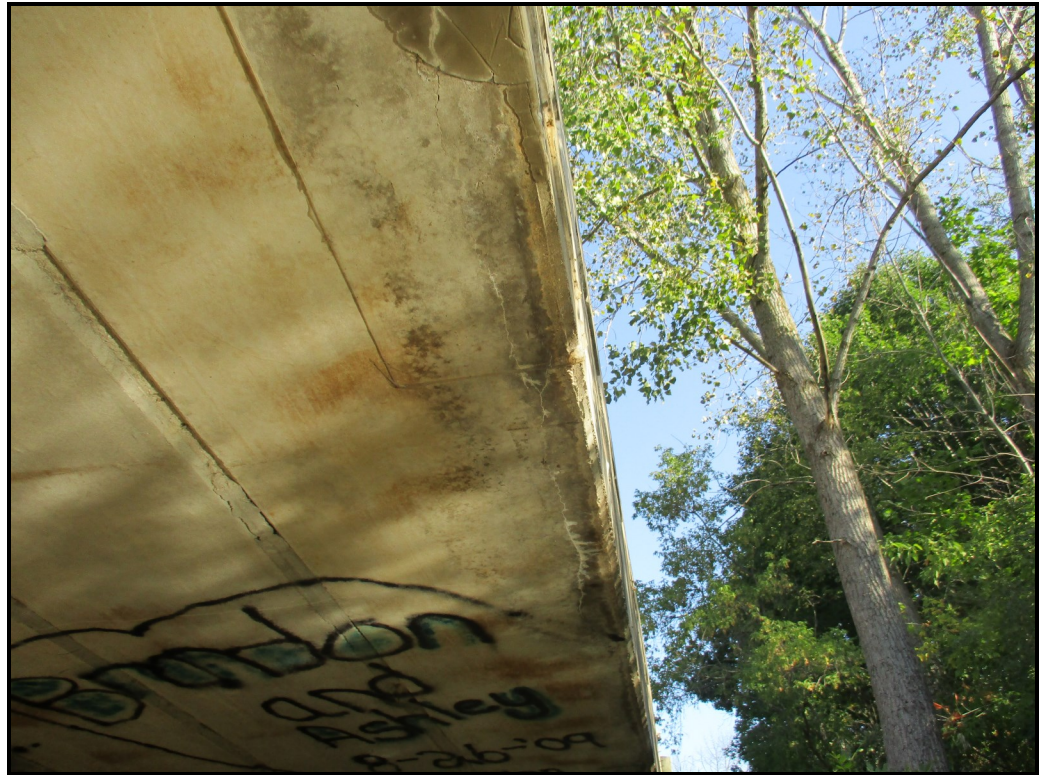
*Leaching crack
on east fascia
beam, span 3S*
